Case Vehicle (A): 1998 Chevrolet

Type: Blazer LS, 4 x 4, 4-door SUV

SITUATION

GENERAL VEHICLE DAMAGE AND ESTIMATED CRASH SEVERITIES

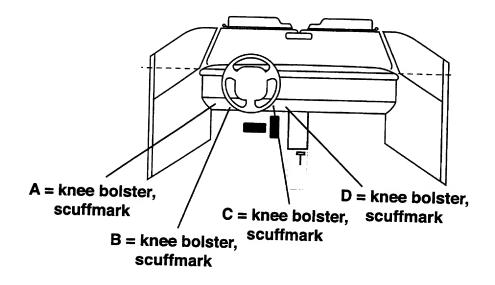
VEHICLE OCCUPANT CONTACT DIAGRAM

Intrus	SION IT-1
					(All Measurements Are in Centimeters)	
Location Intrusion	of 1	Intruded	Component	Compari Value	Dominant Crush Direction	
					_ =	
					_ =	
					= =	
					- =	
					_ =	
					- =	
					= =	
					_ =	
	-				_ =	
					- =	
					_ =	
					- =	
					_ =	
					_ =	
			C	CCUPANT C	ONTACT WORKSHEET	
Contact	C	Interior omponent ontacted	Occupant No. if Known	Body Region if Known	Supporting Physical Evidence	Confidence Level of Contact Point
Α	K	vec bolden	Pn	Lt. KNET	Scuttmark	,
В		//	11	u	0	,
С		//	/1	Rt. KNES	14	,
D		11	И	11	/)	/
E						
F						
G						
Н						
ı						
J

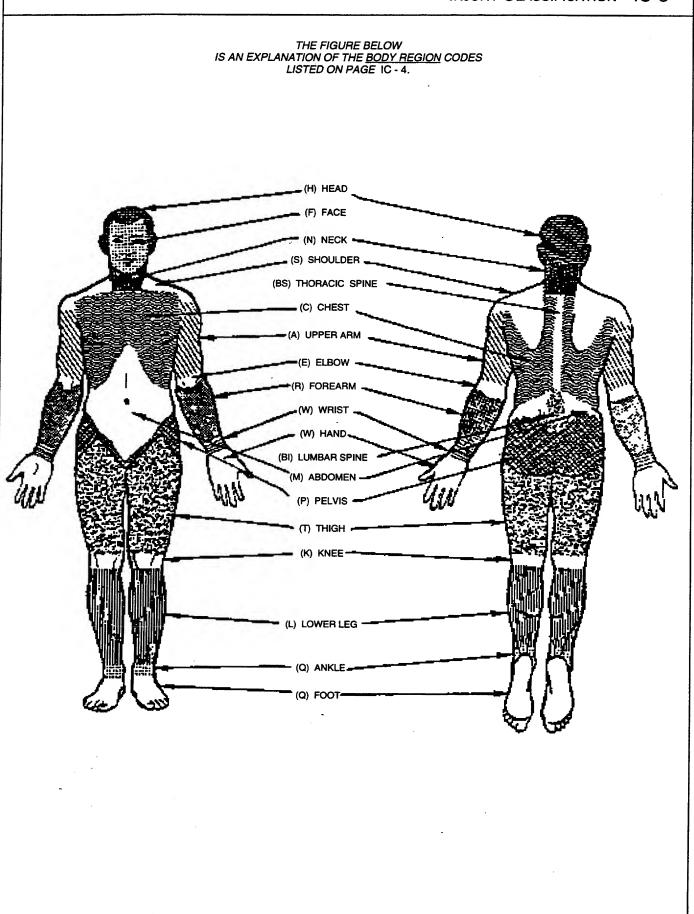
The following table and attached drawing (slide 47) summarize the injuries for the driver of case vehicle (A).

Injury Source	
Injury Description	A.I.S.	Definite	Probable	Possible
Contusion, across abdomen	1 1		Lap belt	
Contusion, right knee	1		Knee bolster	
Maximum A.I.S. Level	1			
Injury Severity Score				
The second second	1
